Radon Measurement Survey Report

O'Donnell Elementary School 1640 Reckinger Road Aurora, Illinois 60505

Survey Dates: May 1, 2018 thru May 3, 2018

Report Issued: July 3, 2018

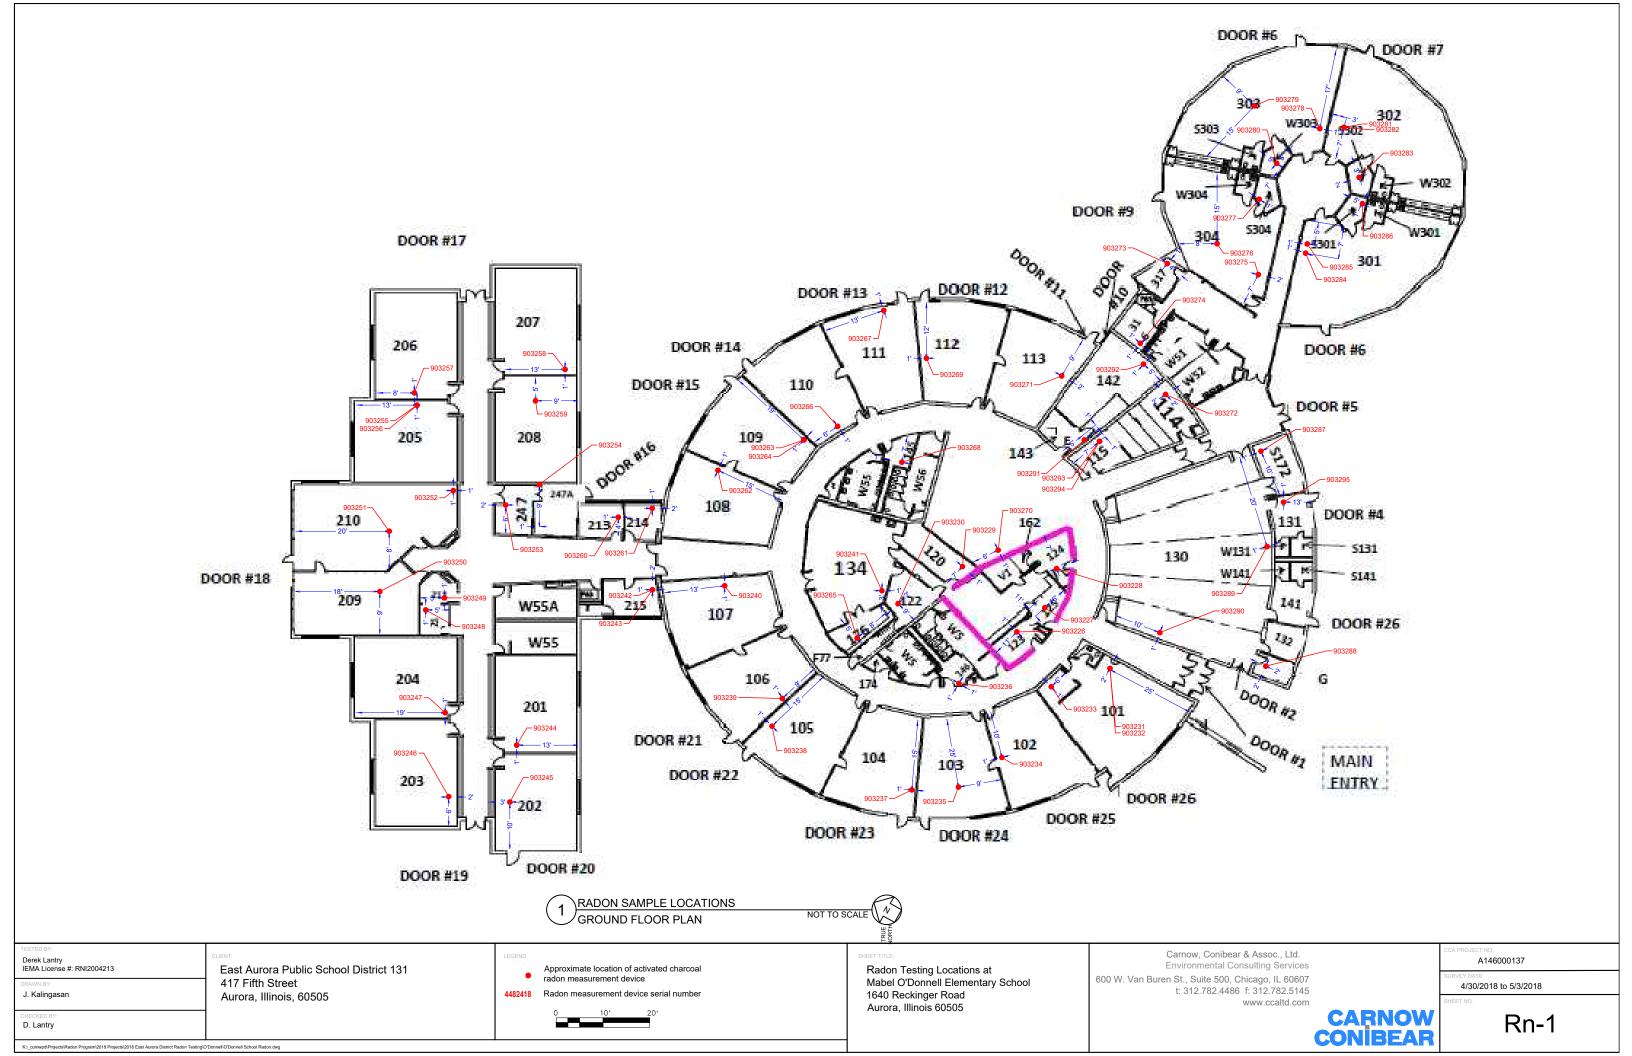
Floor Plans – Radon Sampling Locations

The device (serial #9043251) deployed in Room 210 was missing at the time of retrieval
