#### **Radon Measurement Survey Report**

#### Rollins Elementary School 950 Kane Street Aurora, Illinois 60505

Survey Dates: May 15, 2018 thru May 18, 2018

Report Issued: July 5, 2018

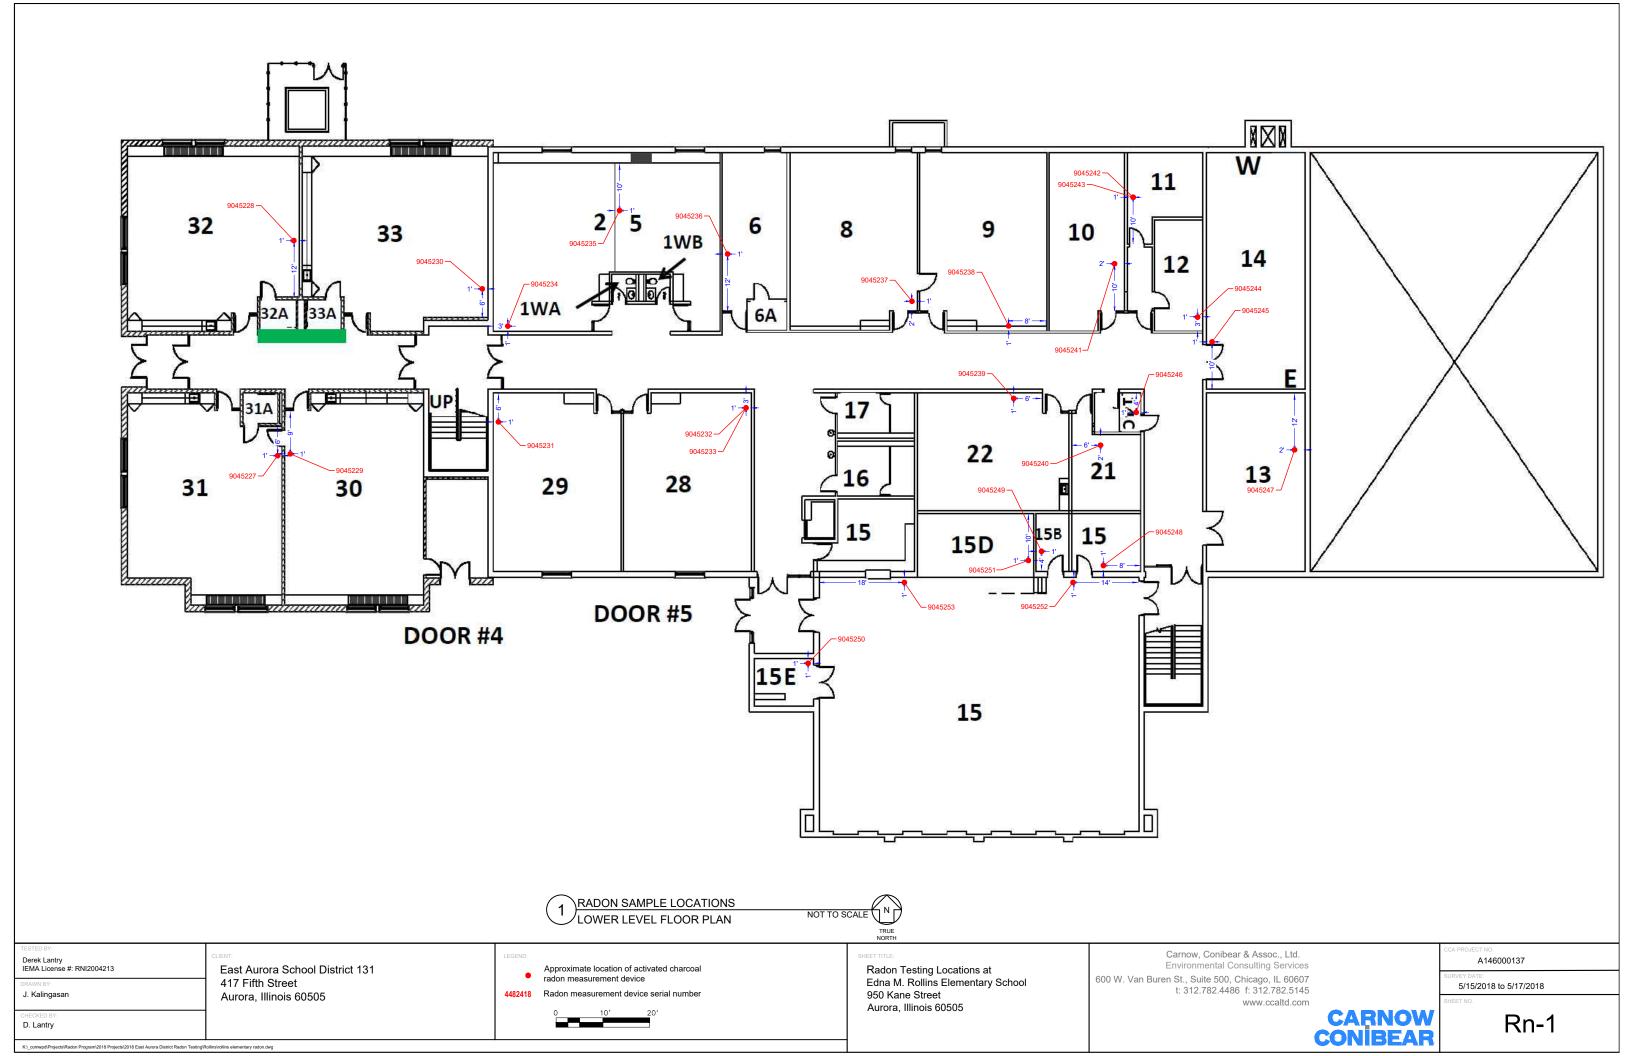
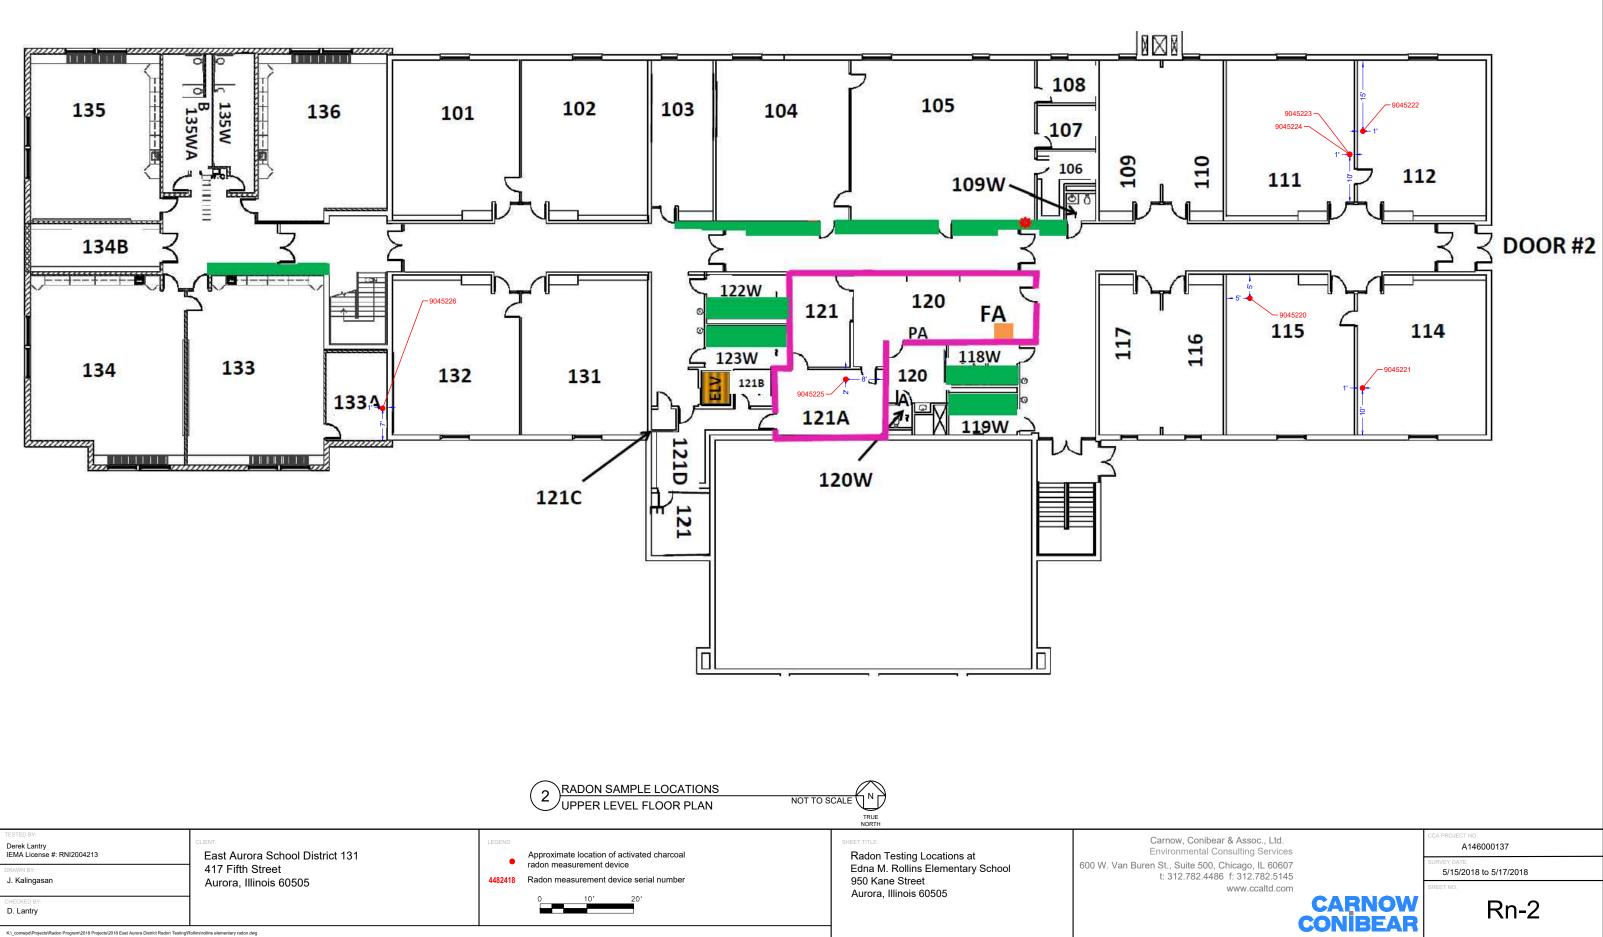
Floor Plans – Radon Sampling Locations

The radon measurement results indicate areas tested exceeded the EPA and IEMA recommended radon action level of 4.0 pCi/L during the time of the test. No radon mitigation systems were observed in the building. Additionally, the following testing abnormalities were noted during the radon measurement interval.

The device (serial #9045230) placed in Classroom 33 was inaccessible at the time of retrieval

- Follow-up radon testing in locations exceeding the EPA recommended radon action level of 4.0 pCi/L. Per IEMA, a recommendation to mitigate elevated levels of radon shall not be based on initial measurement results. Follow-up radon testing is also recommended in locations with invalid test results.
- Routine follow-up radon measurement surveys every two (2) years at different seasonal times following IEMA and the USEPA testing protocols and the radon device manufacturer's recommendations.
- Additional testing if significant changes are made to the building's structural or mechanical components.
