Radon Measurement Survey Report

**Early Childhood Center
278 East Indian Trail
Aurora, Illinois 60505**

Survey Dates: May 9, 2018 thru May 11, 2018

Carnow Conibear Project No. A146000137

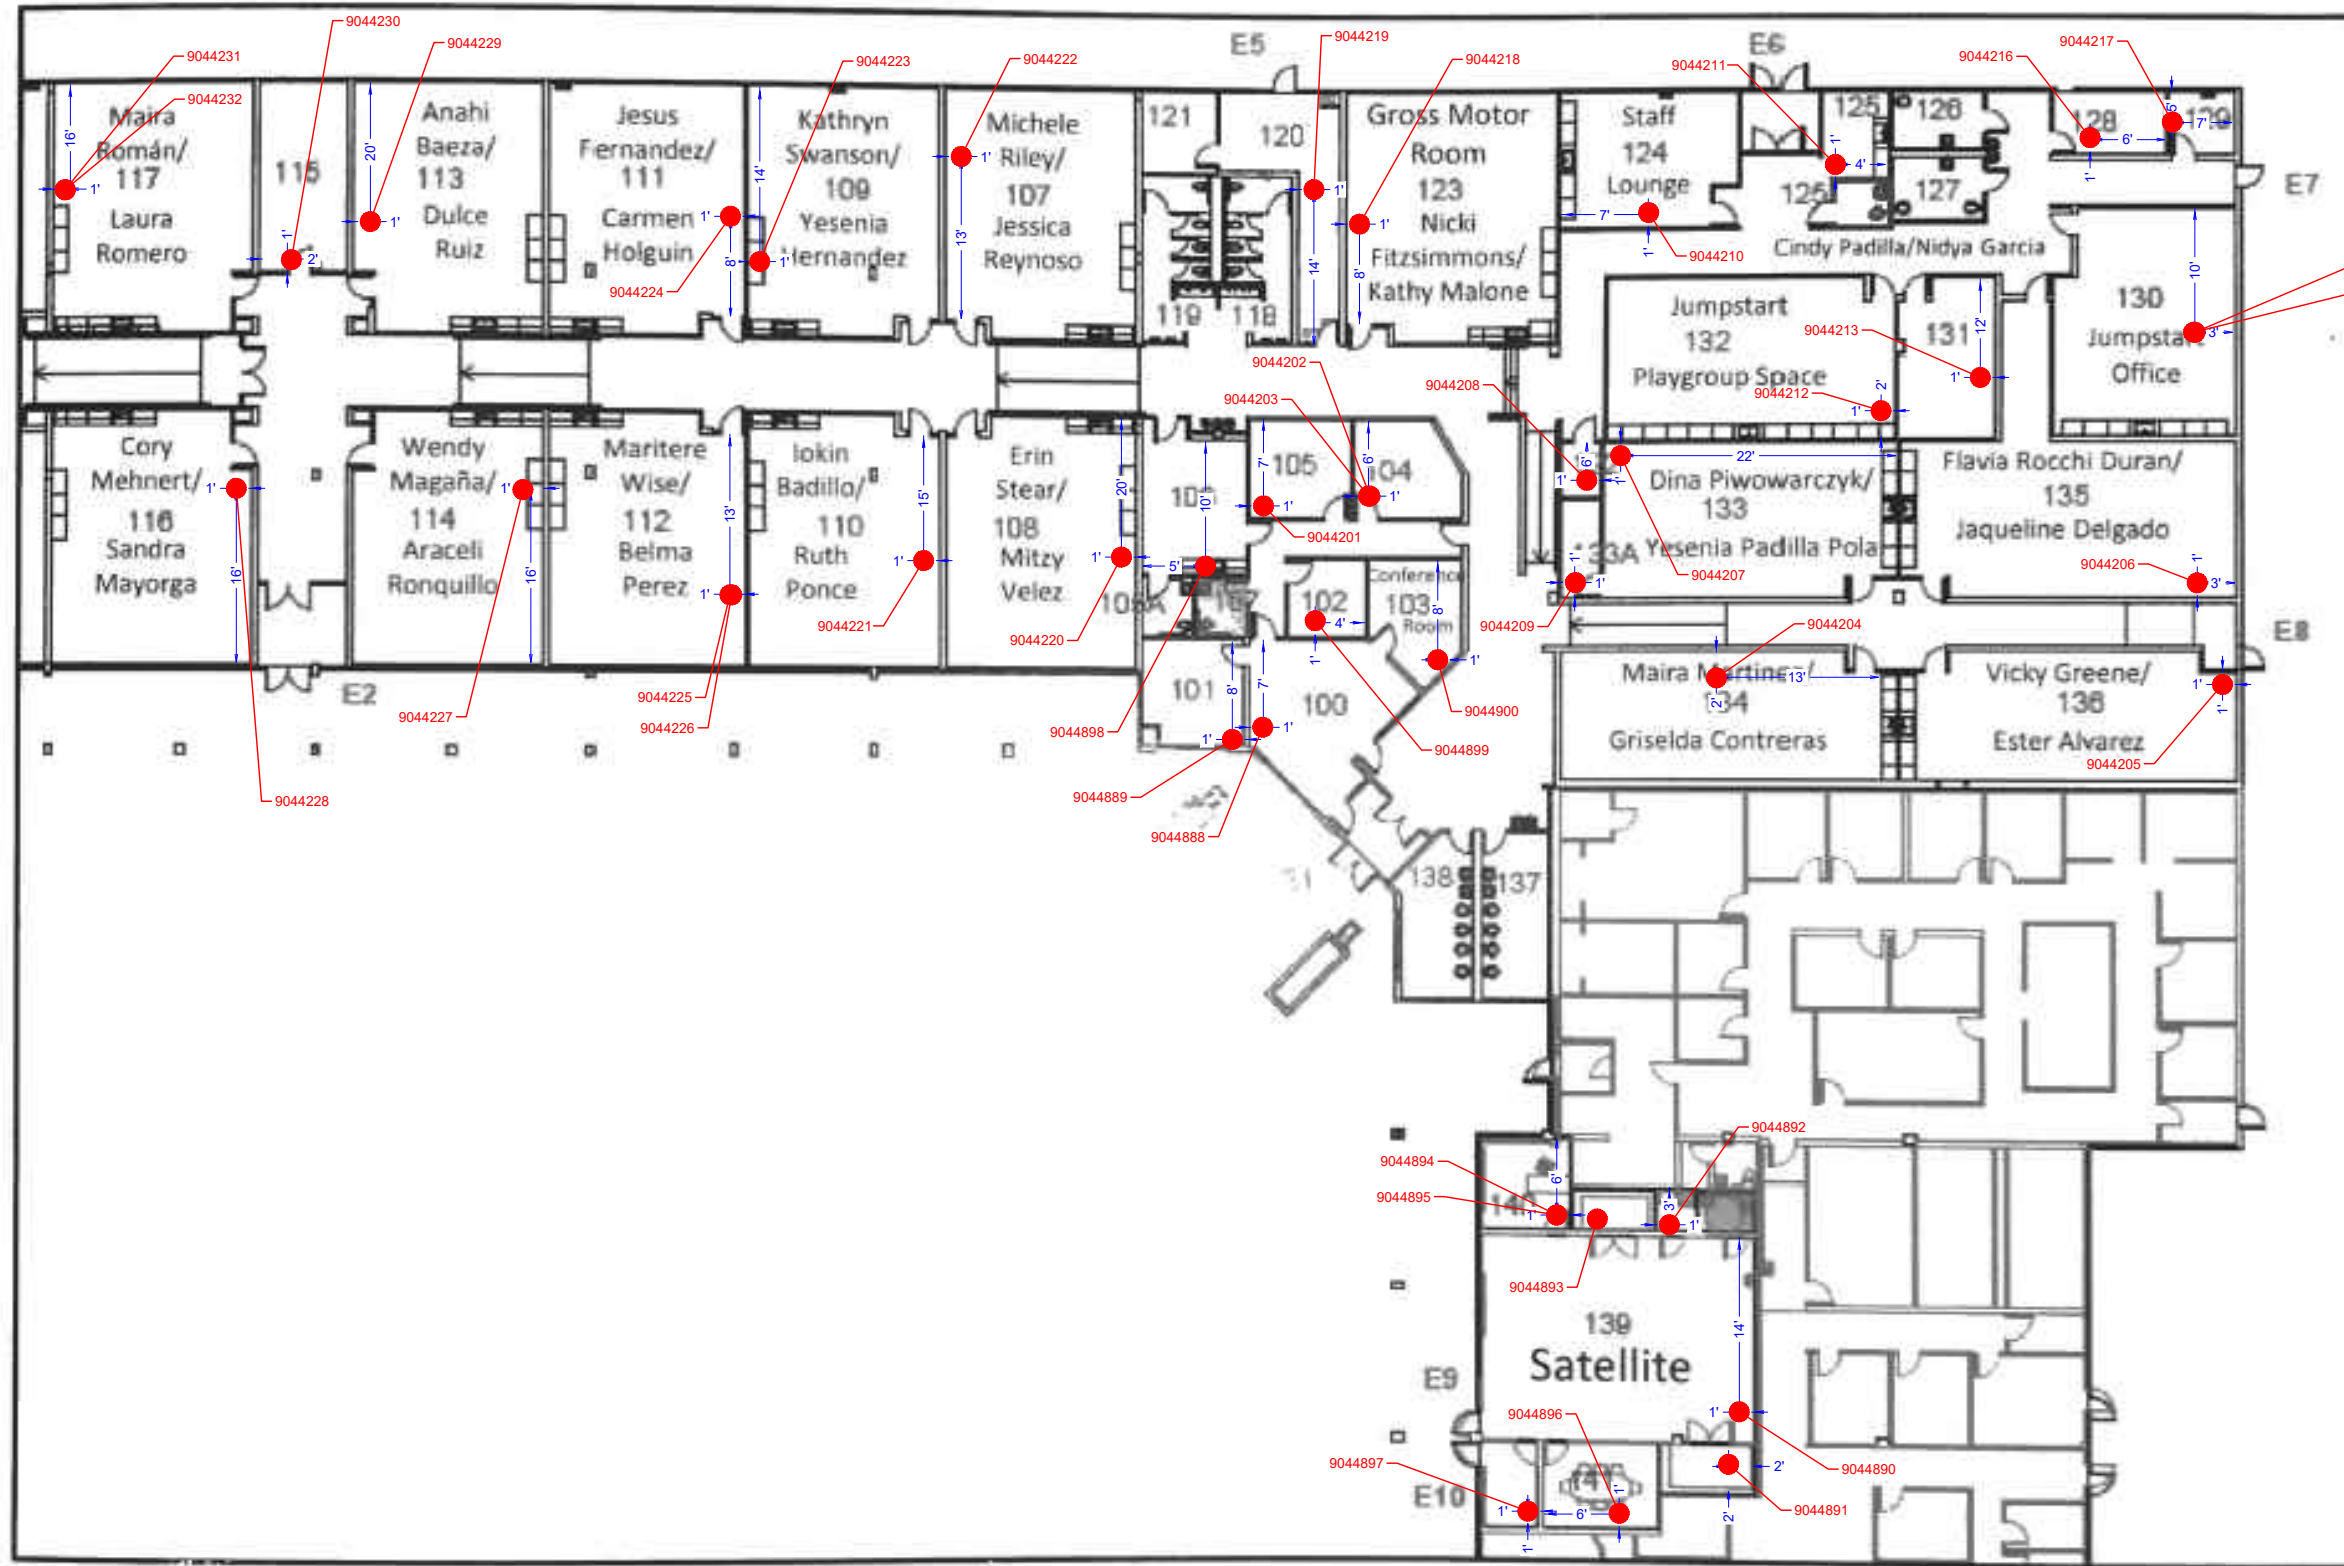
SHEET NO.
Rn-1

1 RADON SAMPLE LOCATIONS
GROUND LEVEL PLAN

- Approximate location of activated charcoal radon measurement device
- 4482418 Radon measurement device serial number
