Radon Measurement Survey Report

Krug Elementary School
240 Melrose Avenue
Aurora, Illinois 60505

Survey Dates: May 1, 2018 thru May 3, 2018

Carnow Conibear Project No. A146000137

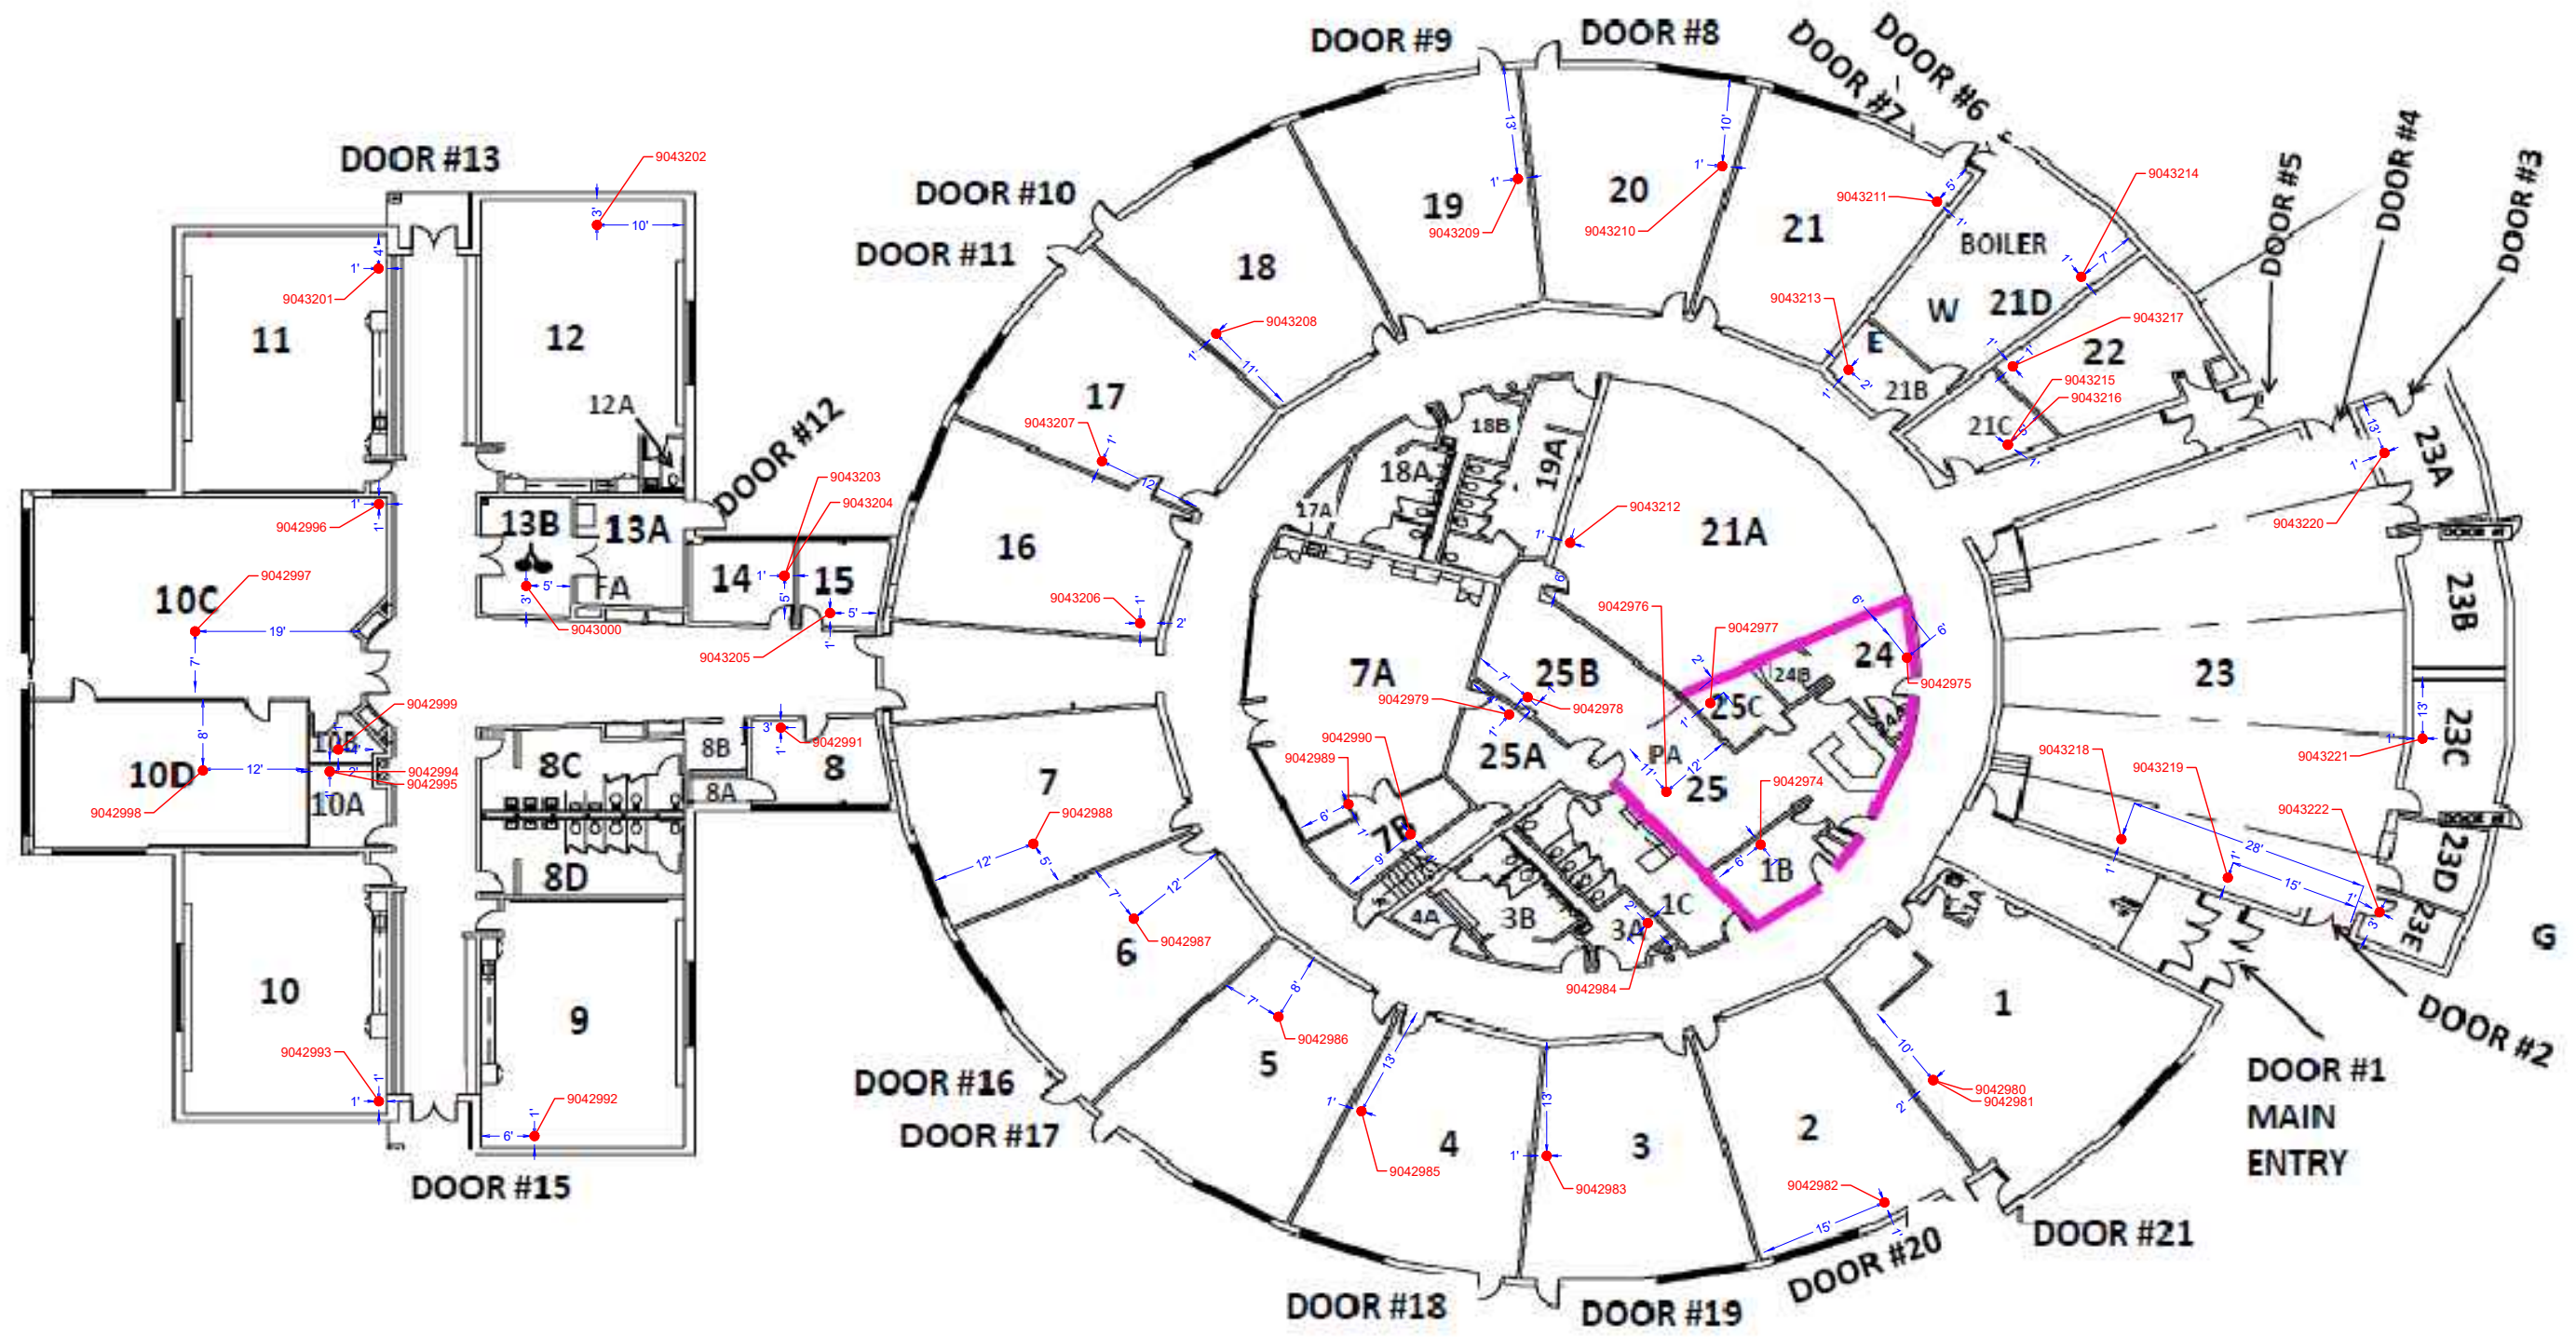
Rn-1

1 RADON SAMPLE LOCATIONS
GROUND FLOOR PLAN

- Approximate location of activated charcoal radon measurement device
- 4482418 Radon measurement device serial number
